JIANGXI GILARDINO BUILDING MATERIALS TECHNOLOGY CO.,LTD
ZHONGXIN ROAD, YUJIANG INDUSTRY PARK, YUJIANG COUNTY, YINGTAN CITY, JIANGXI PROVINCE

Sample Description : SPC FLOORING
SGS Ref No. : XMIN190601490CCM
Sample Receiving Date : Jun. 27, 2019
Test Performing Date : Jun. 27, 2019 to Jul. 8, 2019
Test Performed : Selected test(s) as requested by applicant
Test Result(s) : For further details, please refer to the following page(s)

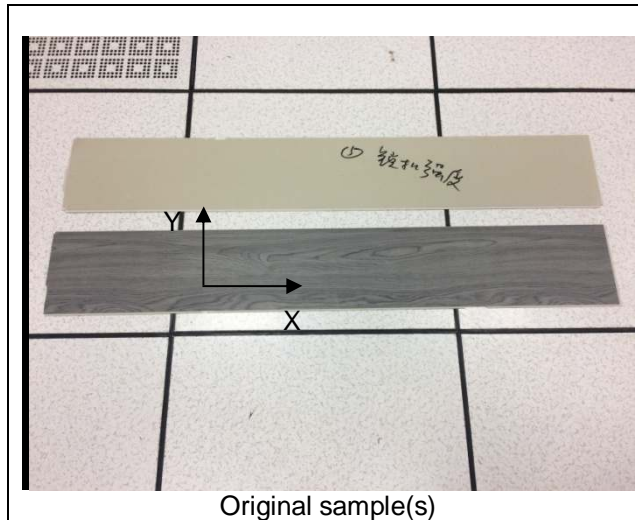
Sample photo(s):

Flooring, See the photograph(s).

Note: 1. All test specimens were cut from the samples, see the photograph(s).

Original sample(s)
